**No. 1545733.6**

SAMPLE DESCRIPTION:  
Kaindl laminate flooring planks assembly.

**ISO 4760:2022(E) - LAMINATE FLOORING – TOPICAL MOISTURE RESISTANCE – ASSEMBLED JOINT (MODIFIED)**

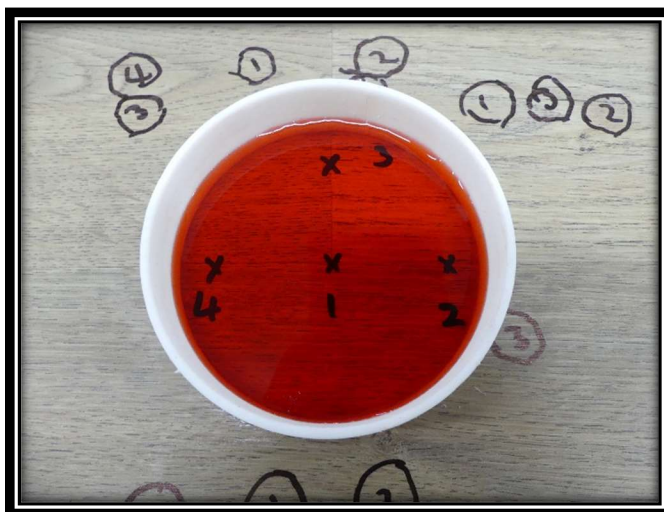
After 24 hrs With Water

100 mls of dye solution was applied onto the sample surface. It was poured into a cylinder 100mm diameter placed in the centre of the sample at the "T joint." Sealant was used at the plank/cylinder interface to avoid leakage.

The sample was left at 20°C, 65% Relative Humidity room conditions for 24 hours after the dye was added and then examined for dye penetration through the backing (not 23°C, 50% RH as stated in the method).

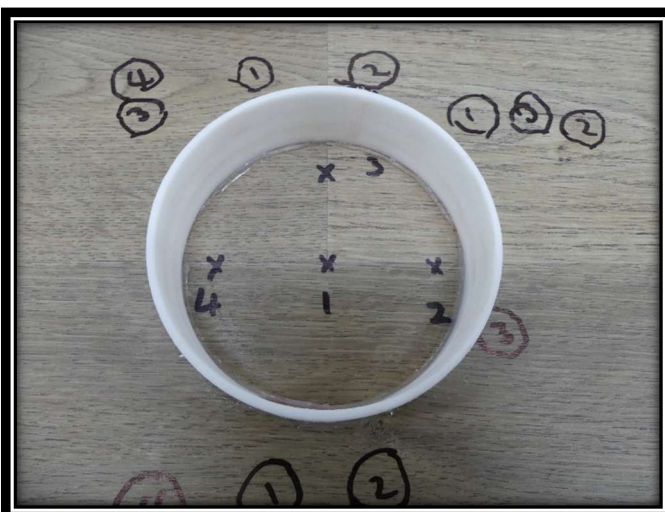
Wet Swell

Quantitative measurements are used to calculate surface swell in mm (within 15 minutes after water removal) and recovery swell (24 hours after removal of water).

| Quantitative Results: | Wet Swell (mm) | | | Recovered Swell (mm) | | |
|---|---|---|---|---|---|---|
| Final Average Results<br>(Positions 2 to 4) | 0.13 | 0.05 | 0.18 | 0.06 | 0.03 | 0.23 |
| Final Results (Position 1) | 0.11 | 0.18 | 0.26 | 0.02 | 0.07 | 0.26 |

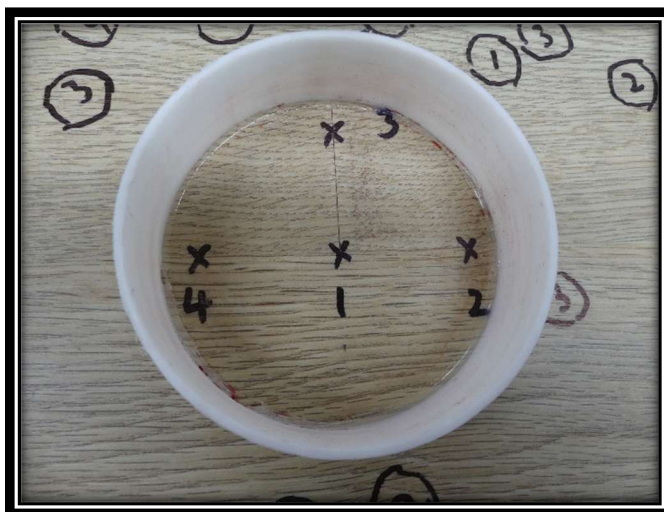
Recovered Swell
