**No. 1545730.2**

SAMPLE DESCRIPTION:  
Kaindl laminate flooring planks skirting assembly with  
Selleys Wet Area sealant applied in the skirting joints.

**ISO 4760:2022(E) - LAMINATE FLOORING – TOPICAL MOISTURE RESISTANCE – ASSEMBLED JOINT (MODIFIED)**

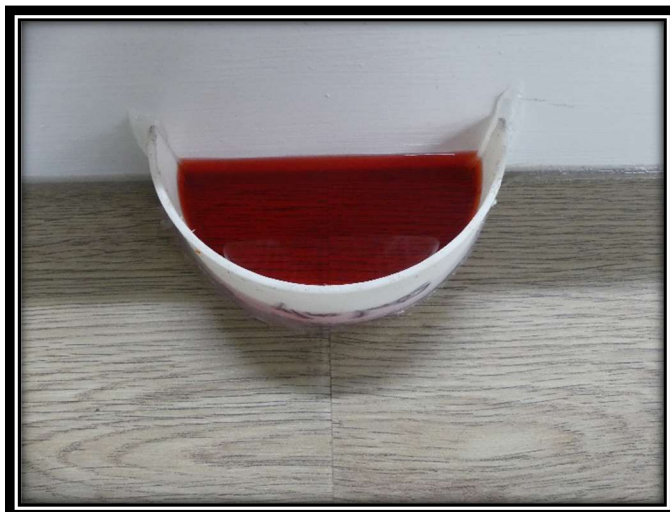
After 24 hrs With Water

| Observations: | Specimen 1 | Specimen 2 | Specimen 3 |
|---|---|---|---|
| Migration of water along the upper surface: | No | No | No |
| Migration of water to the underside: | No | No | No |

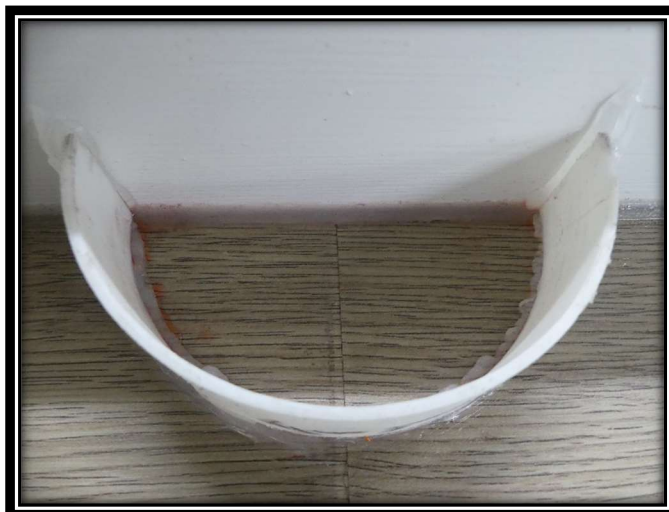
Wet Swell

| | Wet Swell | | | Recovered Swell | | |
|---|---|---|---|---|---|---|
| Qualitative Ratings<br>(individual results): | 1 | 1 | 1 | 1 | 1 | 1 |

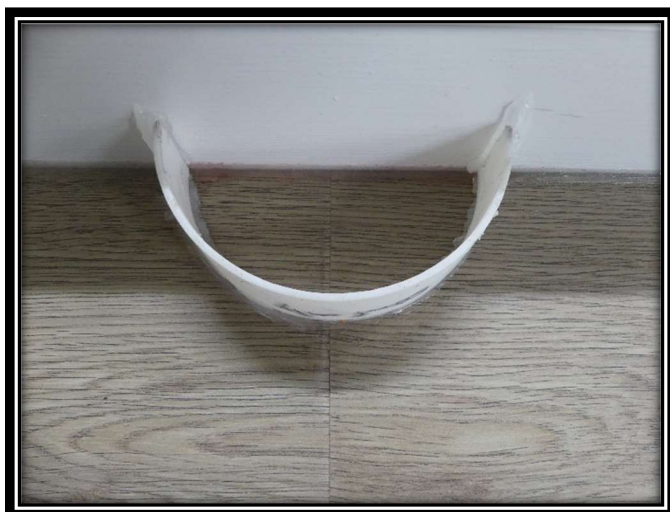
Recovered Swell

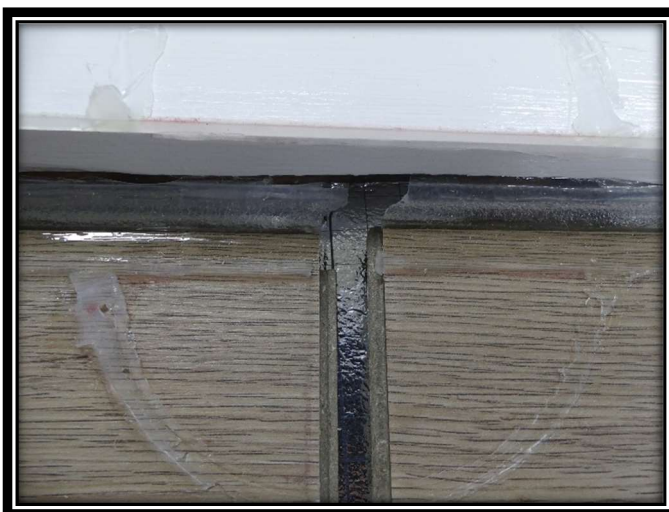
Recovered Swell (Disassembled)

| Disassembly Observations: | Specimen 1 | Specimen 2 | Specimen 3 |
|---|---|---|---|
| Migration of water along the upper surface: | No | No | No |
| Migration of water to the underside: | No | No | No |
